# ETHICON,INC.

September 30, 1987

IR MICROSCOPY OF EXPLANTED PROLENE\*
RECEIVED FROM PROF. R. GUIDOIN

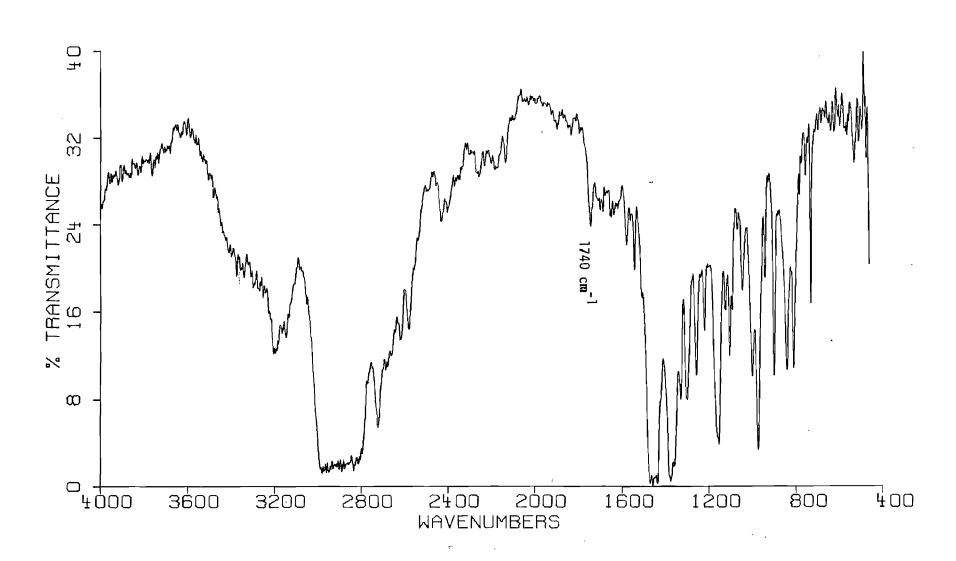
Figure 1

PROLENE EXPLANT (2 YR) 830062 + 83TM020

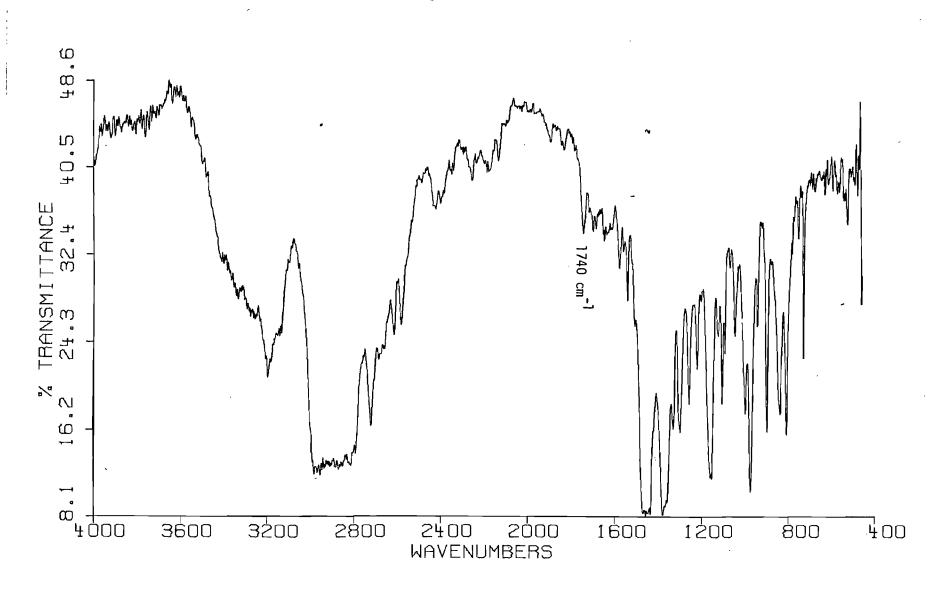
Figure 2

PROLENE EXPLANT (2 YR) 83D062 83TM020 SIZE 2/0?

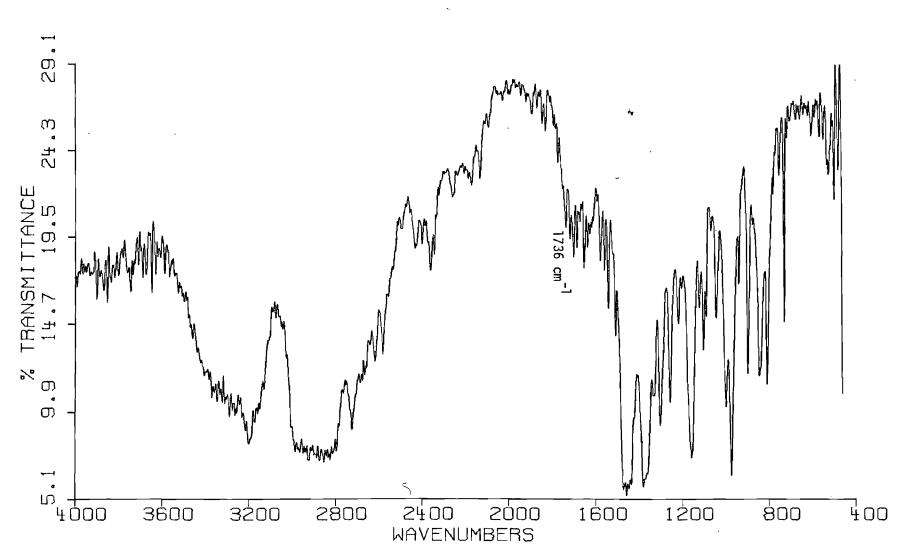
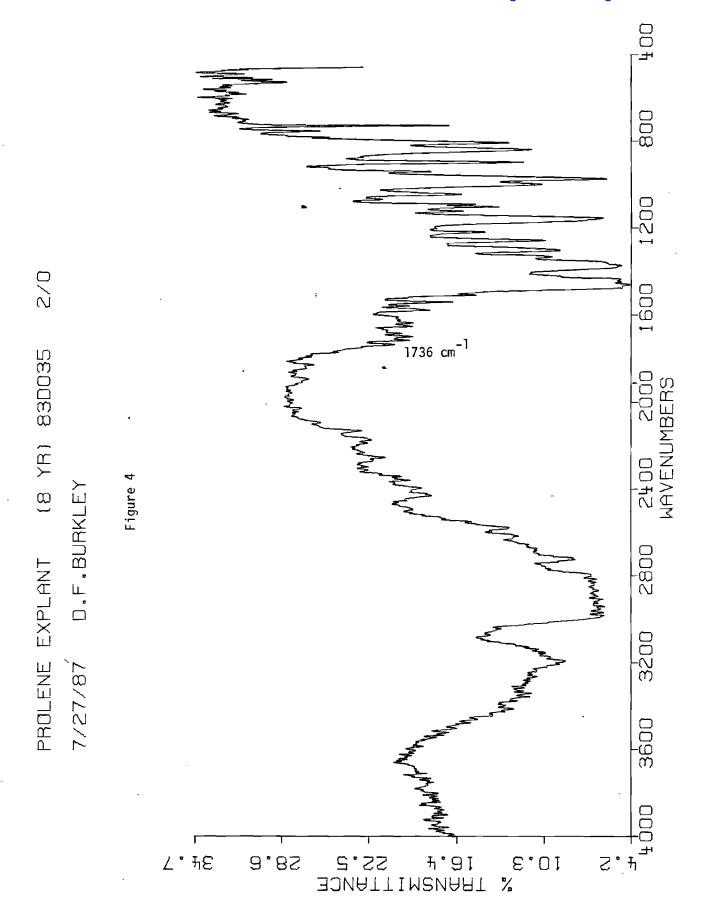
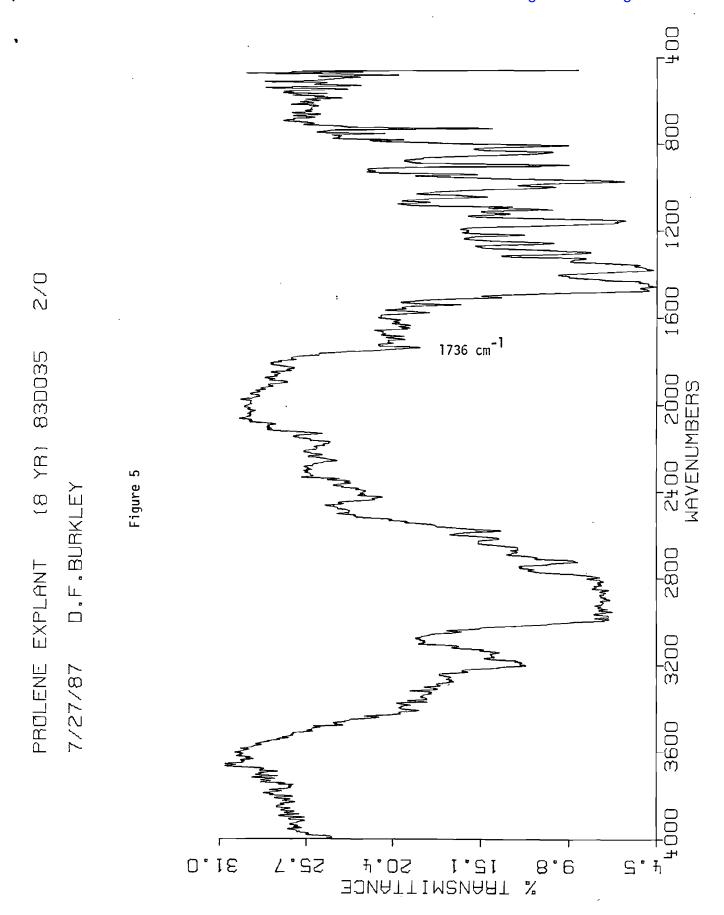
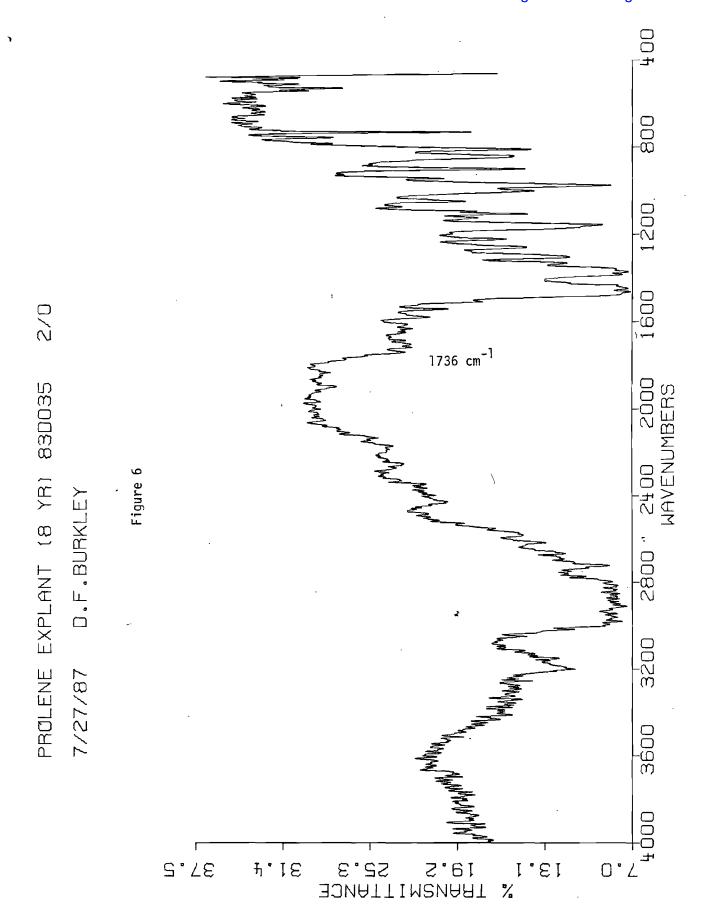
PROLENE EXPLANT (8 YR) 83D035 2/0

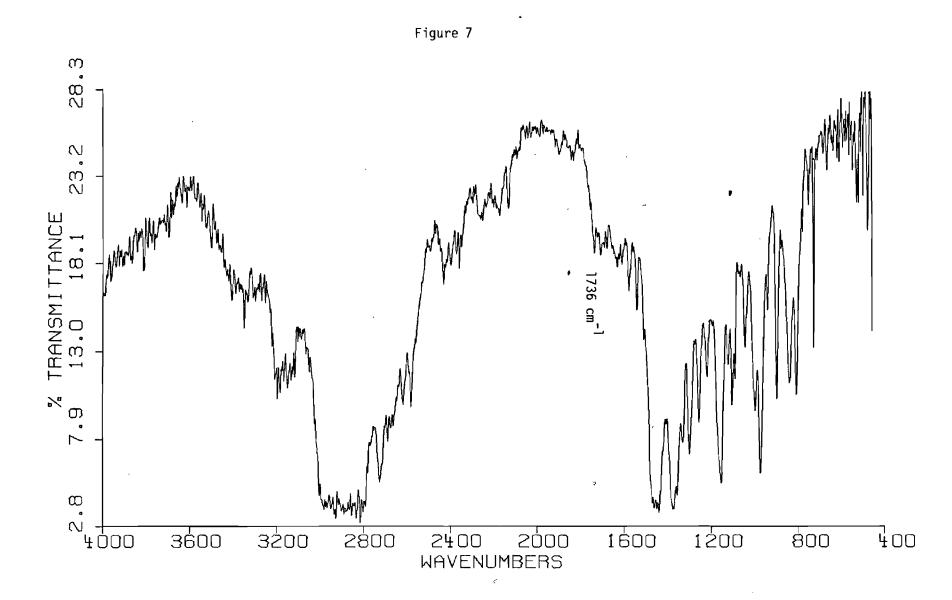
PROLENE EXPLANT (8 YR) 83D035 2/0

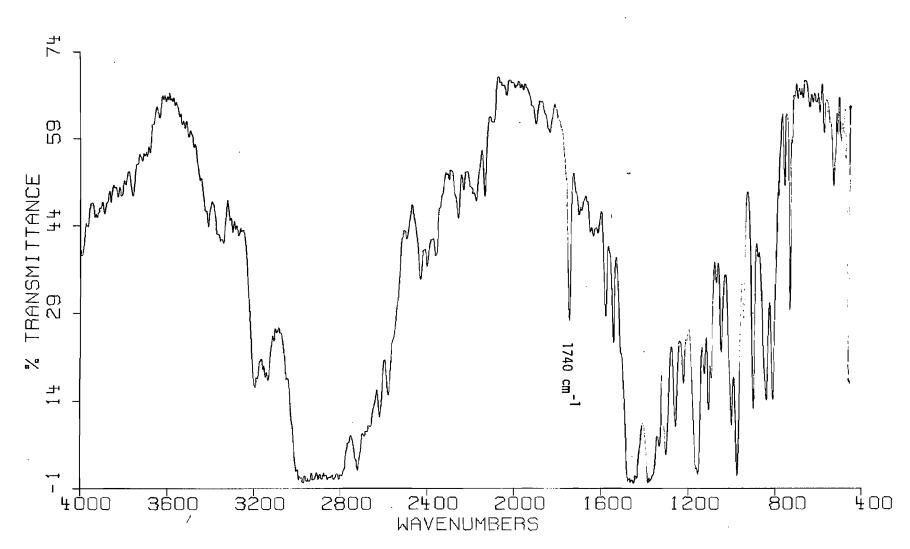
Figure 8

SIZE O PROLENE STERILE PACKAGE IR MICROSCOPY 9/1/87 D.F.BURKLEY

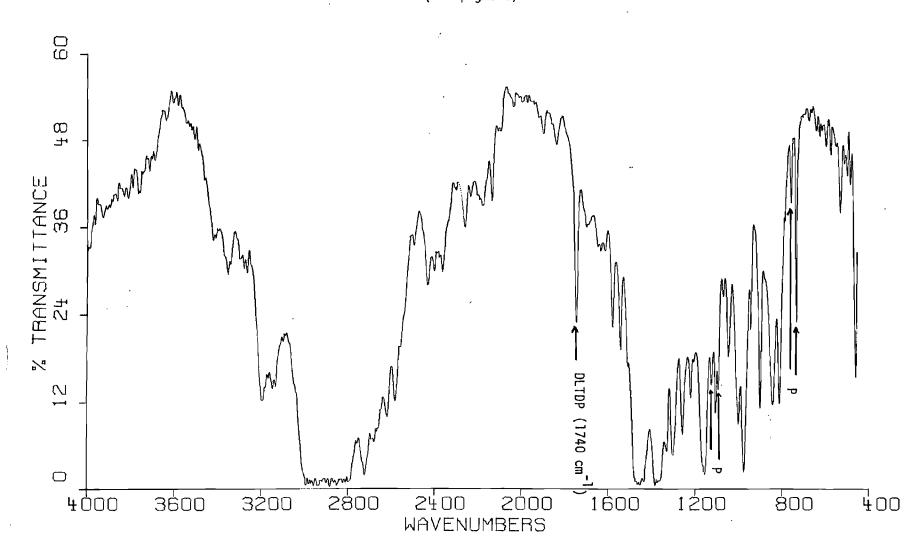
Figure 9 - DLTDP and pigment bands shown (P = pigment)

Spectra of samples examined "as is" show remarkable similarity between explanted suture and unimplanted suture. All major polypropylene and pigment bands are observed (Figure 9). The 1740 cm<sup>-1</sup> band, seen strongest in the sterile product, is due to dilauryl thiodipropionate (DLTDP) additive. The DLTDP appears reduced in the 2-year sample spectra and further reduced in the 8-year sample spectra. DLTDP is not observed in the surface scraping spectra.

SIZE O PROLENE STERILE PACKAGE IR MICROSCOPY 9/1/87 D.F.BURKLEY

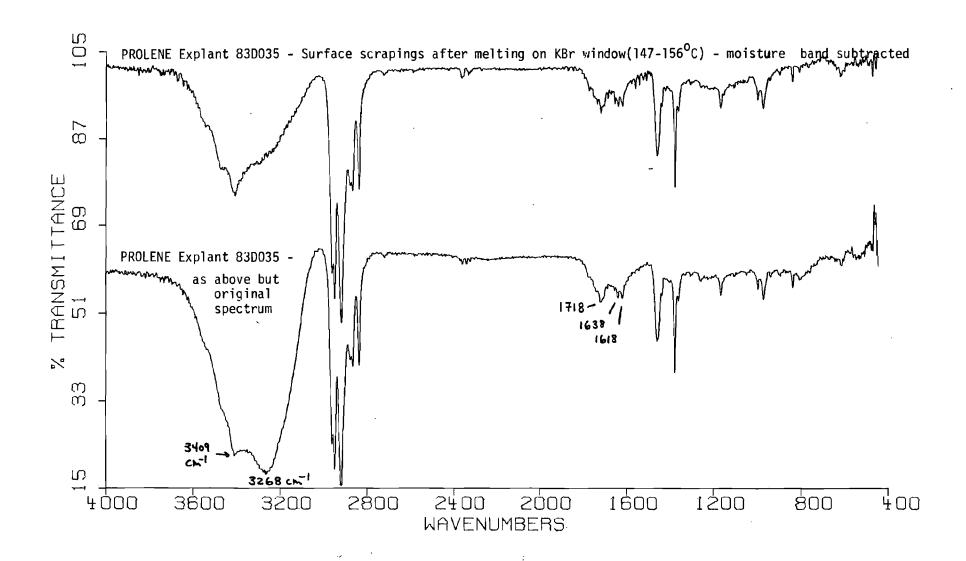
Figure 10

The surface scrapings of 83D035 were melted at 147°-156°C on the Mettler hot stage. This is the melting range previously observed for oxidatively degraded polypropylene. IR microscopy of the melted film produced (Figures 10 & 11) yielded good spectra.

The surface scrapings spectra of 83DO35 clearly indicate polypropylene, but also three or four other broadened bands. Table I explains the possible functionalities determined from a library search of the IR bands not normally seen in polypropylene.
